# PROJET ANR PGCU ERINOH

## Érosion INterne dans les OuvragesHydrauliques

## Essais de laboratoire

(CEMAGREF)

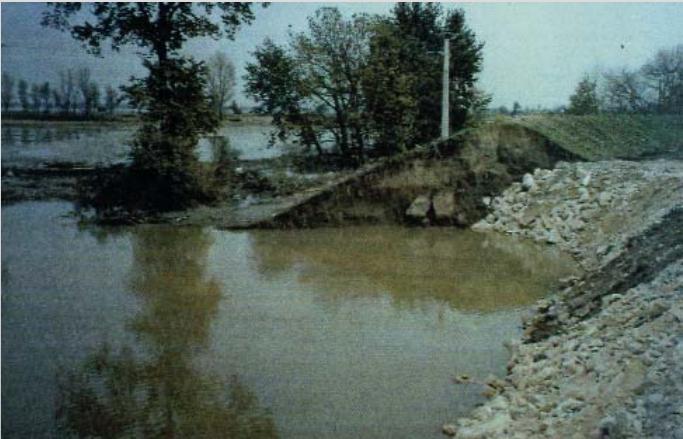
## 1993 Camargue dikes, France

- 12 breaches in December 1993 and 4 breaches in January 1994

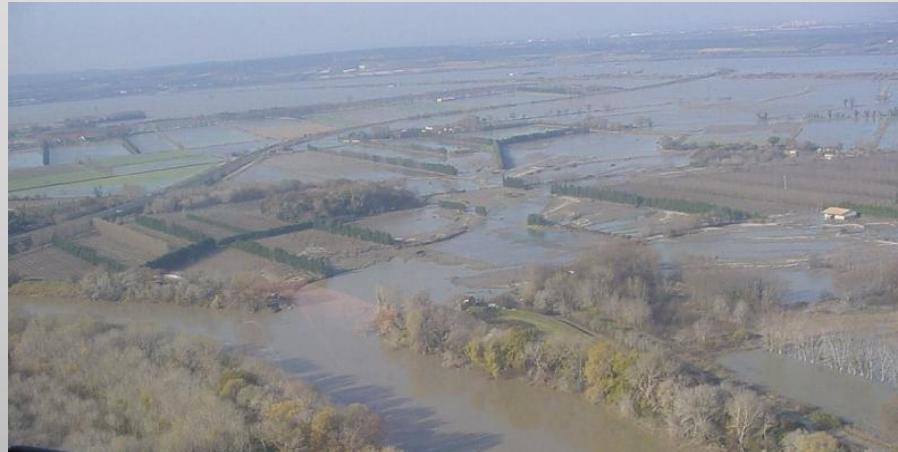
## Saint-Gilles flood, 2003

- Breache of Fourques, Petit Rhône Rive Droite

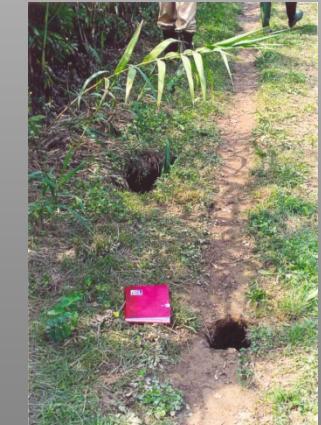
## Rupture of Aramon dike, 2002

- 3 total breaches
- 3 partial breaches
- 5 fatalities

- Sinkholes

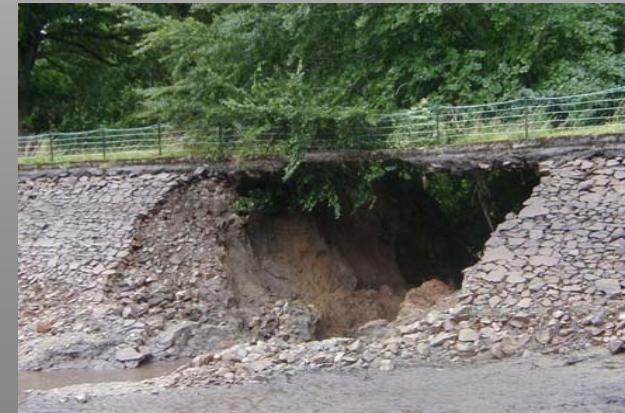
**ERINOH 2008 → Four types of internal erosion:**

- Regressive erosion
- Contact erosion
- Suffosion
- Piping flow erosion

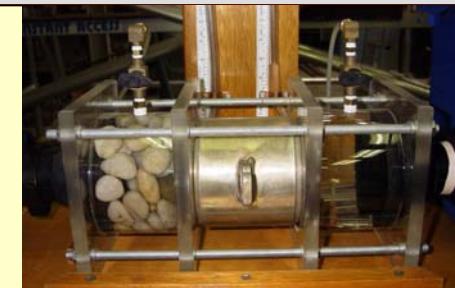
Wan and Fell (2002, 2004)

- Seuil d'érosion  $\tau_c$
- Coefficient d'érosion  $k_d$

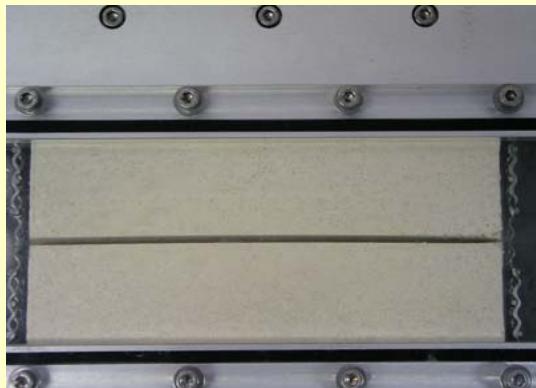
Sample before erosion

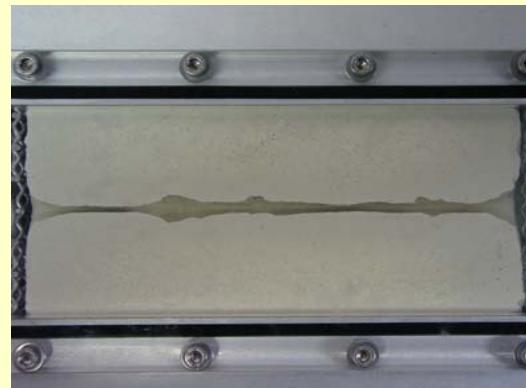
Sample during testing

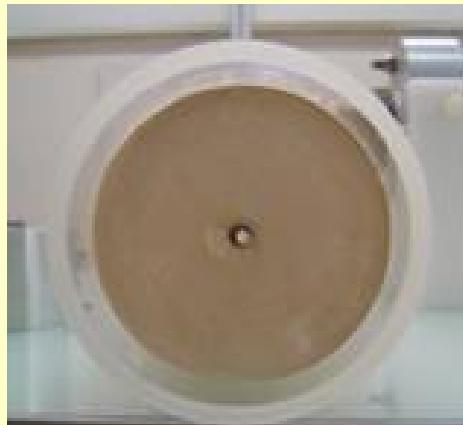
Sample before erosion

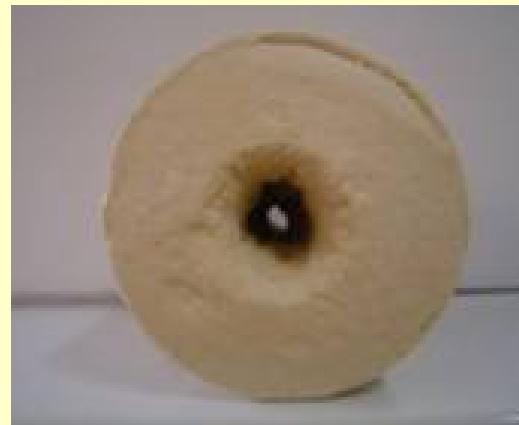
Sample after erosion

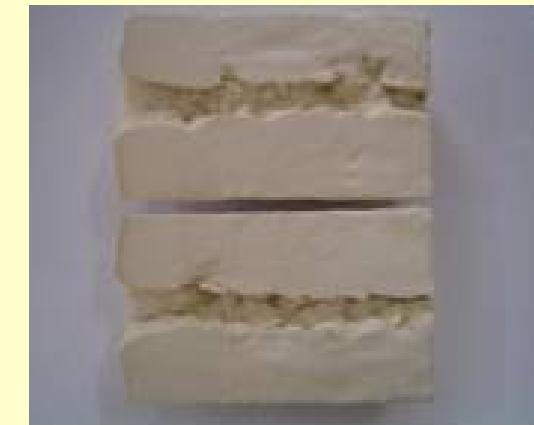
Sample after erosion

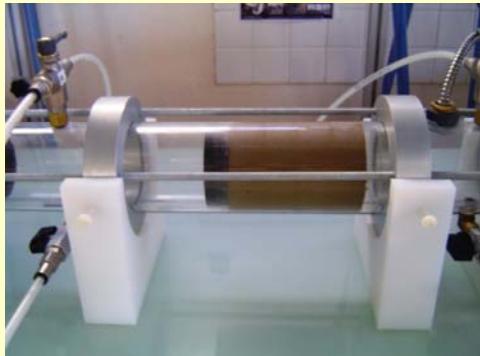
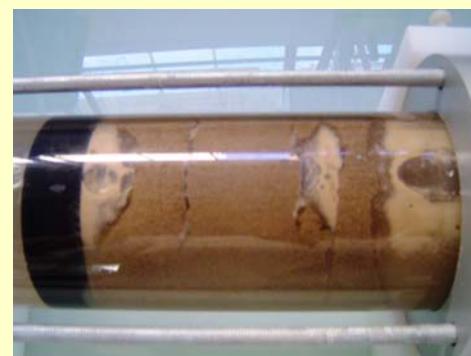
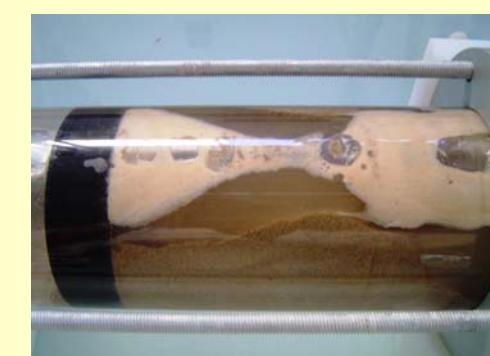
**Naturel soil : Sandy silt (72% sand, 23% silts, 4% clay)**

**Collapse of the sample during filling of the testing cell**

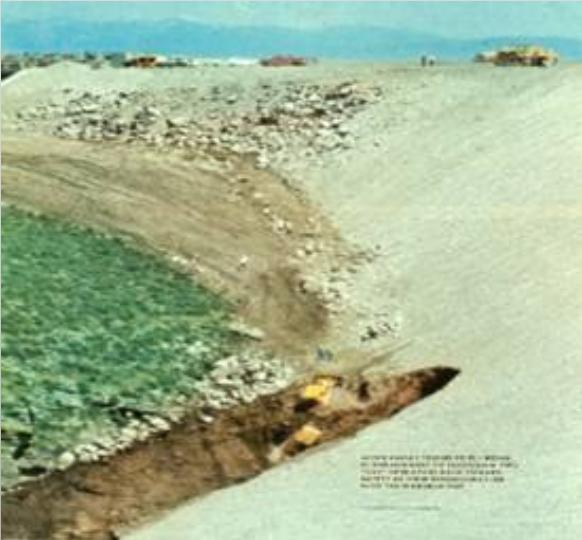
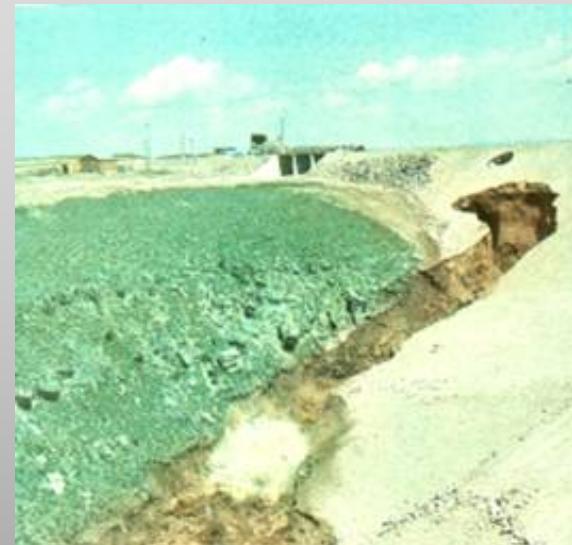
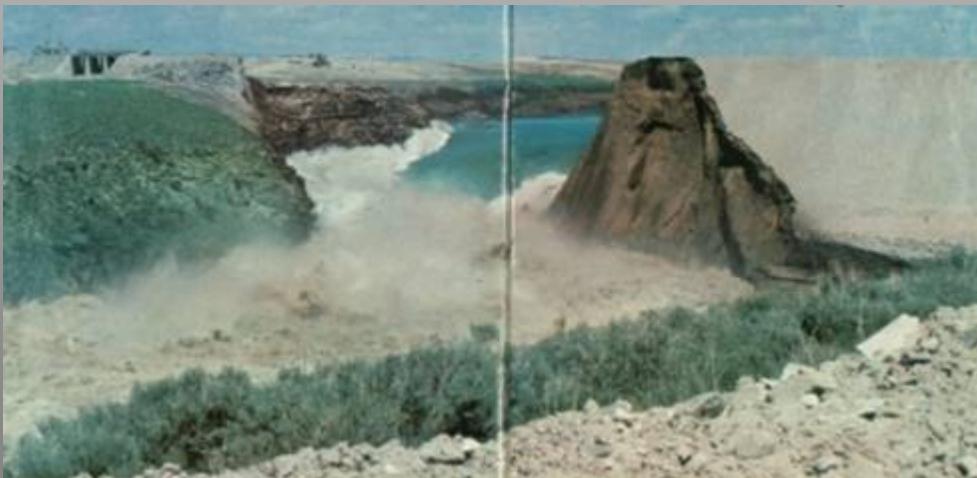
## Failure of Teton Dam by piping

➡ Failure:  
On 3 hours only!
