Liquéfaction des sols sous séisme

Paris, 24 mars 2010

Retours d'expériences anciens et récents

P. MOUROUX

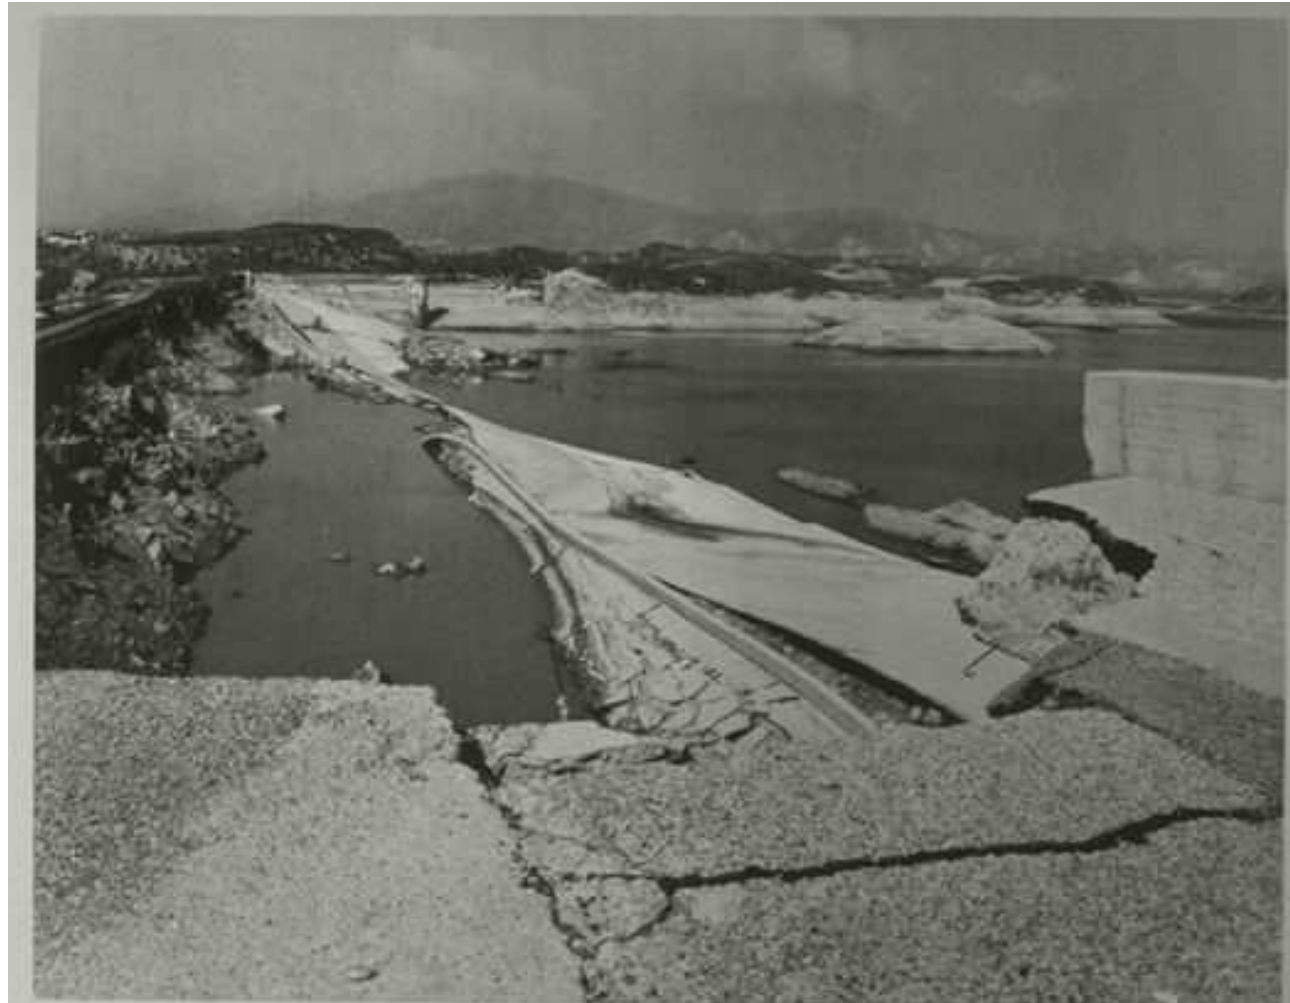
FIG. III-17 SLIDE DAMAGE TO LOWER SAN FERNANDO DAM.
(Photograph by Department of Water Resources, Feb. 22, 1971)

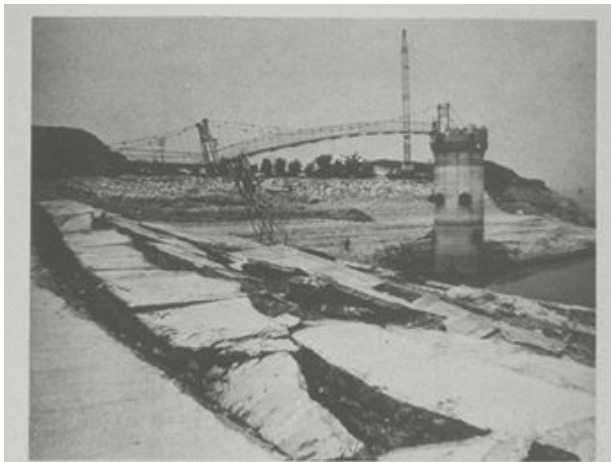
FIG. III - 18 SLIDE DAMAGE NEAR WEST ABUTMENT -
LOWER SAN FERNANDO DAM

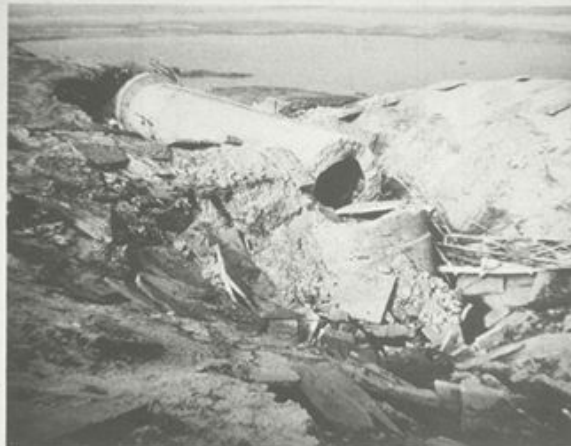
FIG. III-19 CENTRAL OUTLET TOWER - LOWER SAN FERNANDO DAM

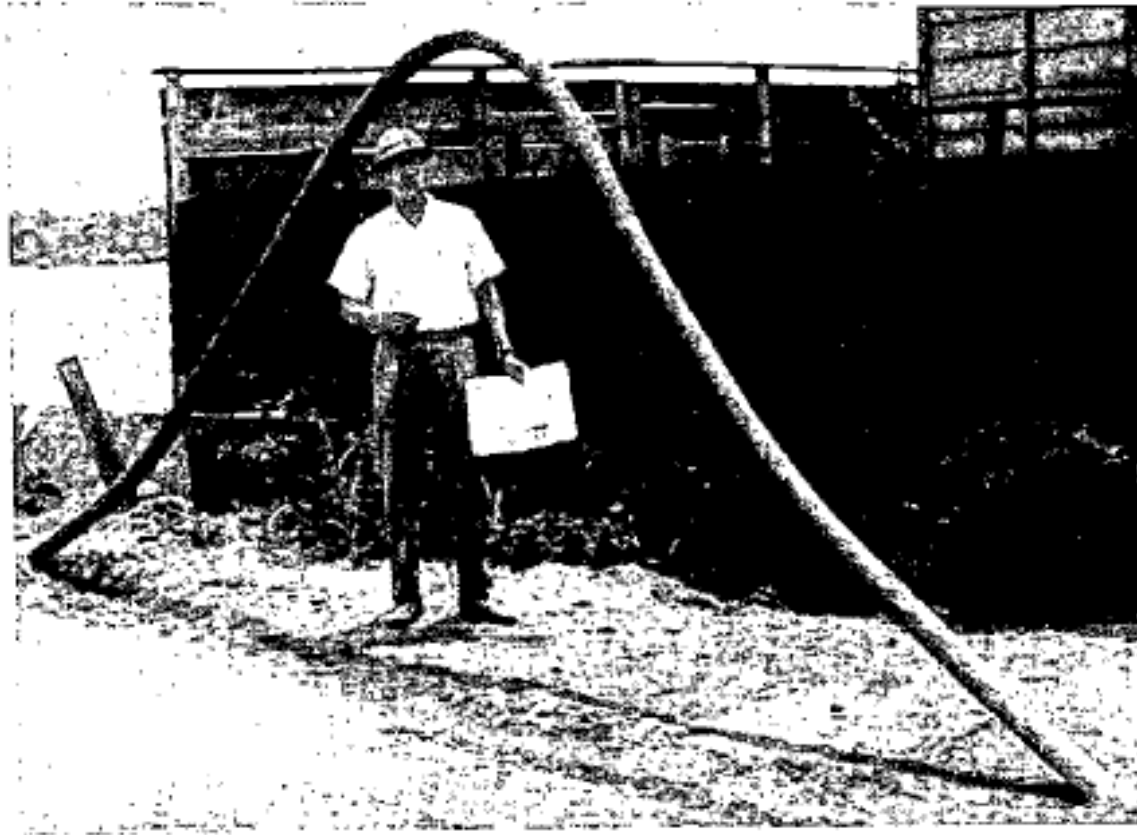
Photo 31 Buckling of a Buried Gas Pipe

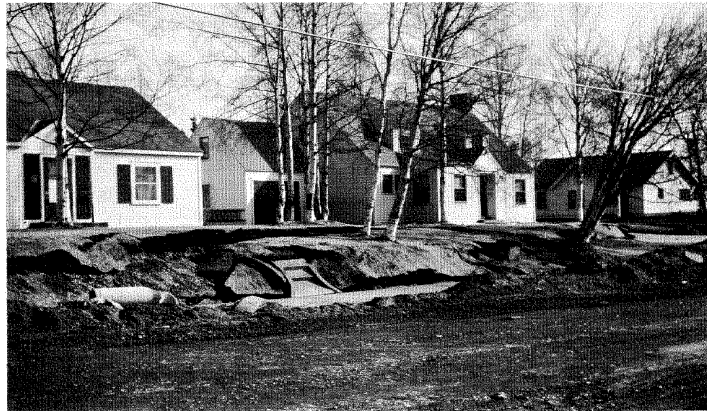
Fig. 36 – UNDAMAGED HOUSES ALONGSIDE GRABEN, L – STREET SLIDE AREA, ANCHORAGE (1964).

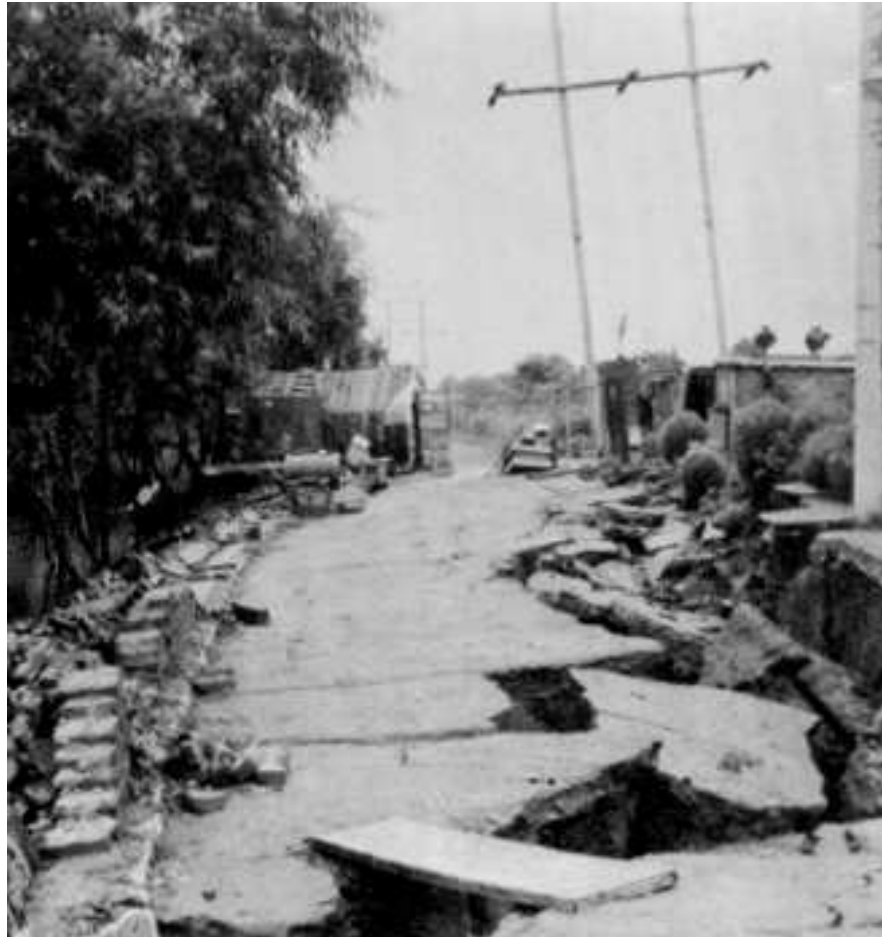
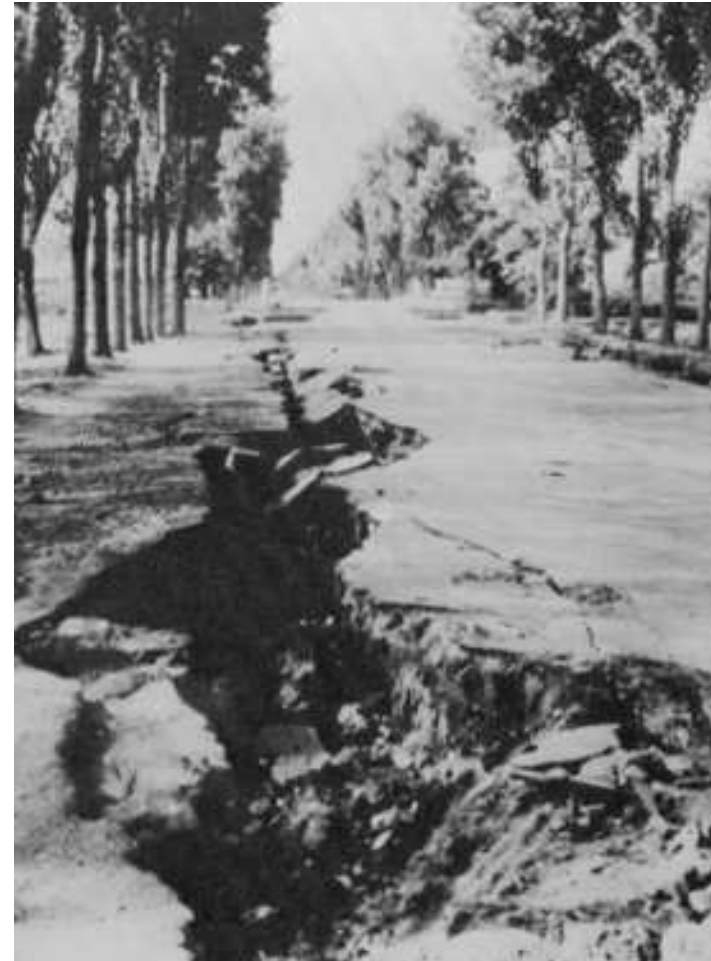
Figure 23. Damage to road near Loting Hsien. Slumping, lurching and settlement of soft soils caused extensive damage to highways in the Tangshan region.

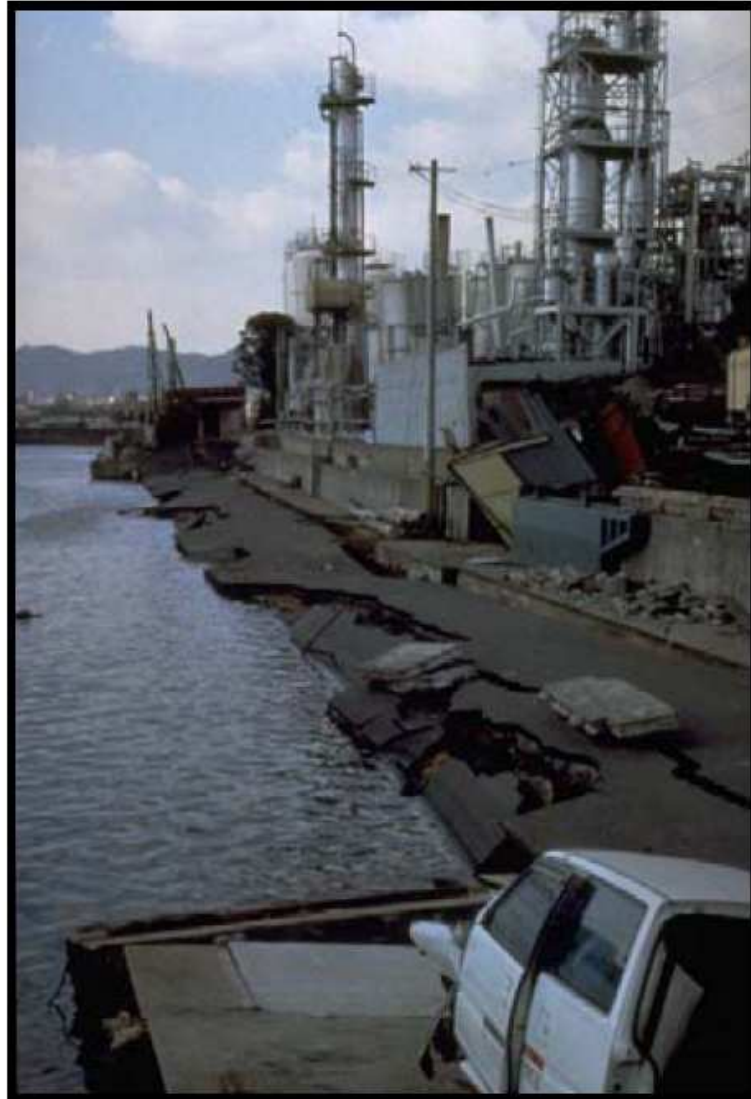
1995 Kobe Earthquake –
Example of damage to port facilities
Source – Kobe Geotechnical
Collection,
Earthquake Engineering Research
Center,
University of California, Berkeley

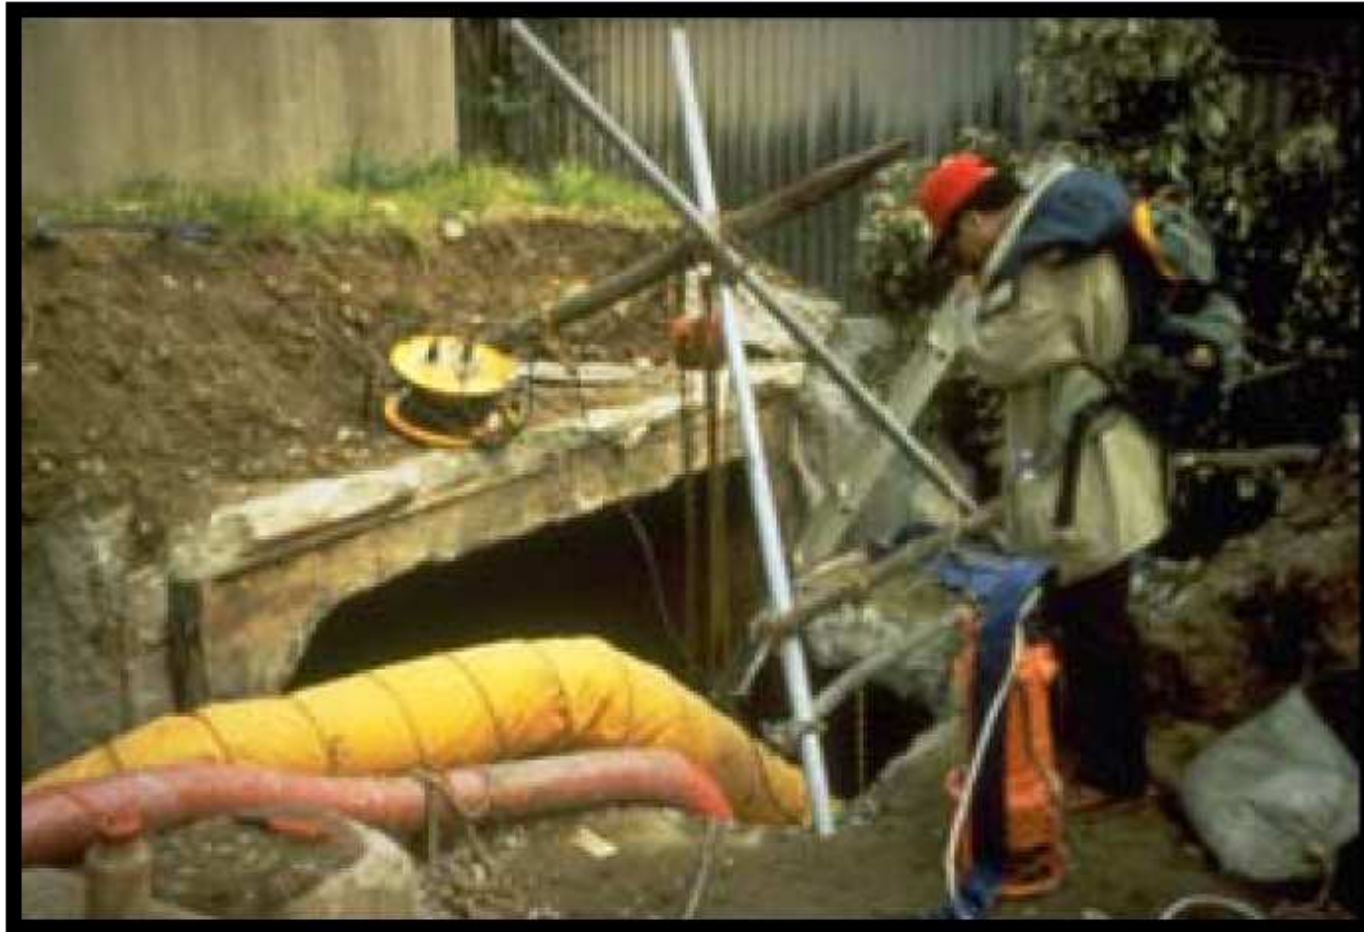
Example of main sewage treatment conduit rupture in the 1995 Kobe Earthquake
Source – Kobe Geotechnical Collection, Earthquake Engineering Research Center, Univ. of California, Berkeley

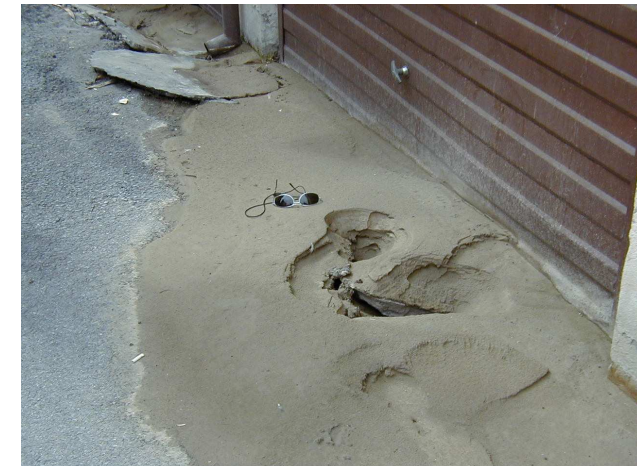
Figure 12.2 Sand volcano observed on Aug. 18, 1999 in Erenler (Adapazar)

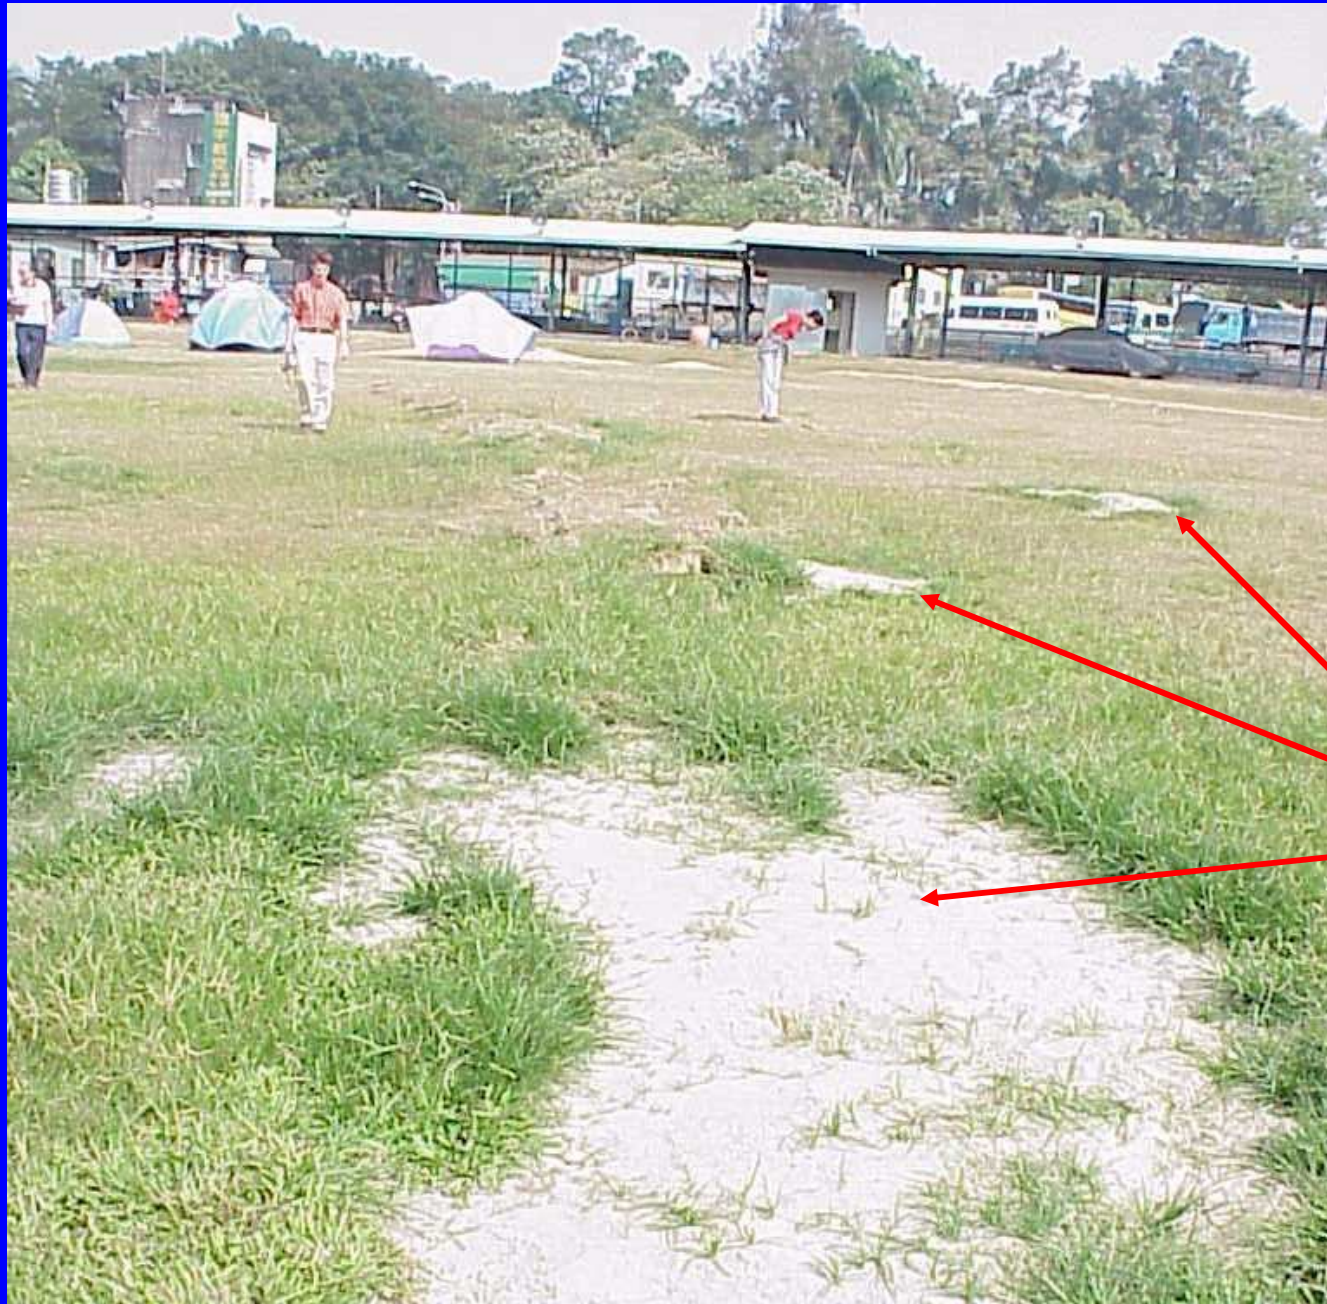
Sinkhole initially created by liquefaction but expanded significantly due to washout of sand between caissons.

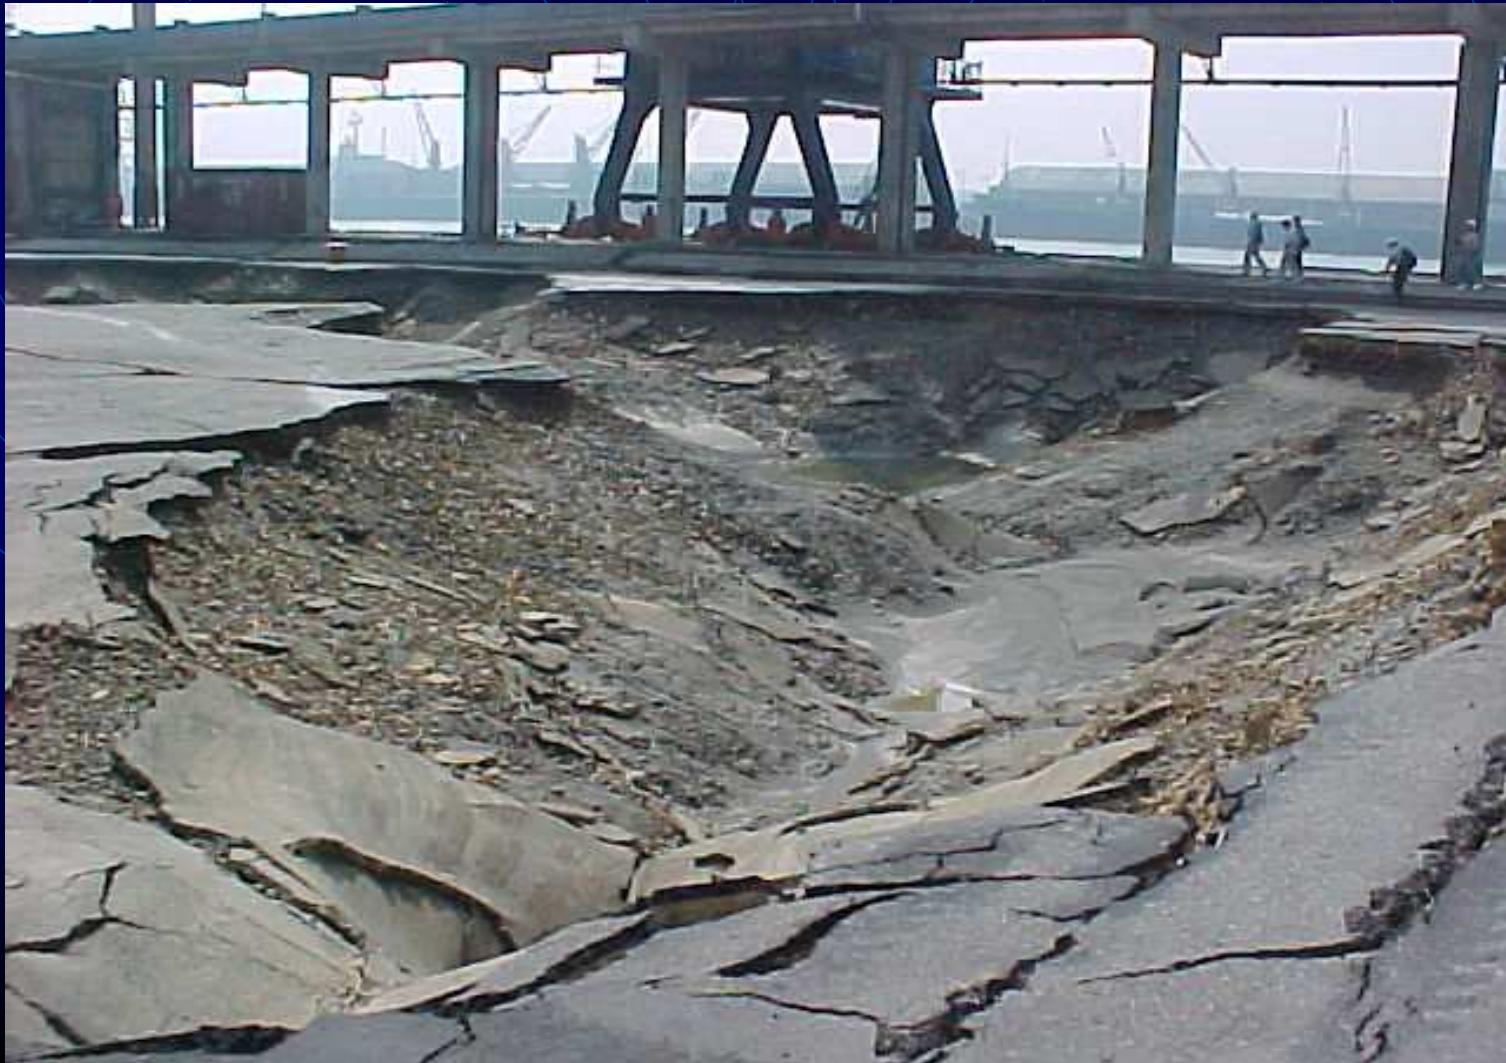
Liquefaction at inward side of levee and at base of power line tower foundation shown in background.

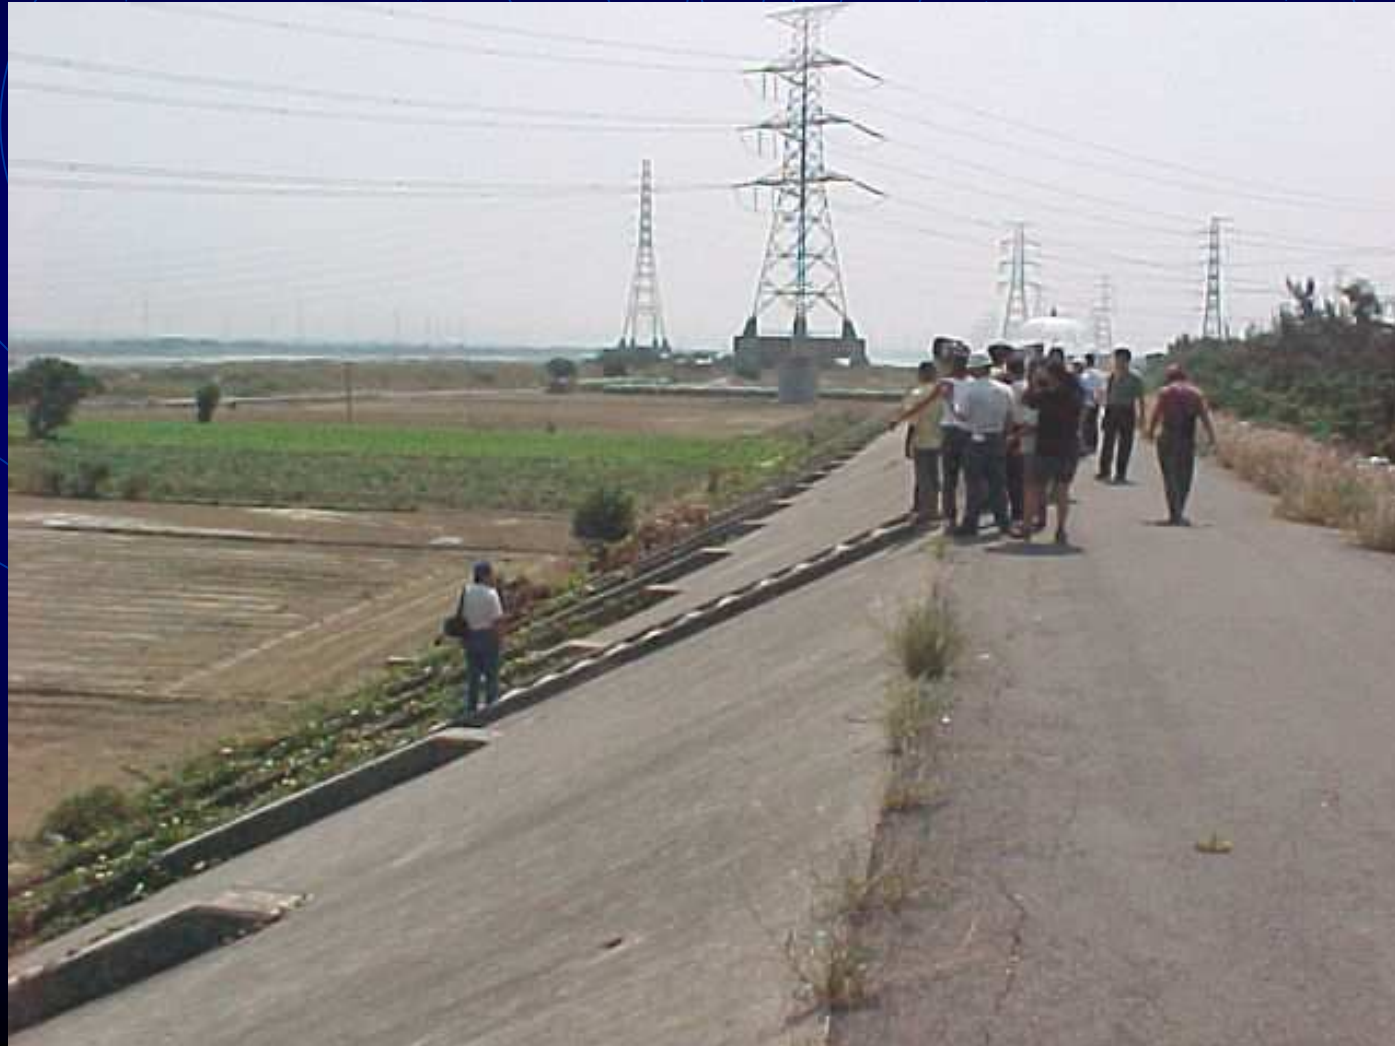
Settlement failure due to liquefaction.

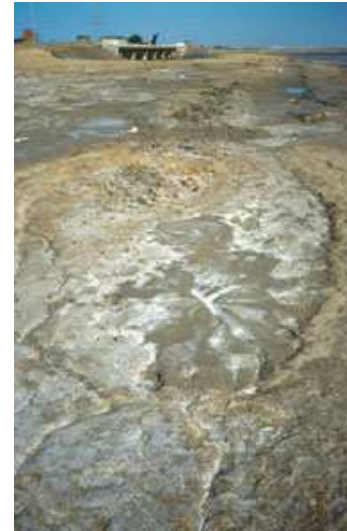
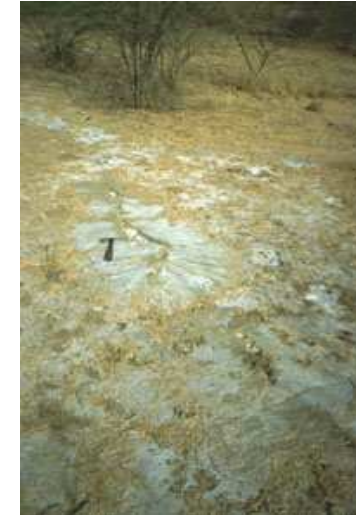
Photo 3.5 : Volcans de sable

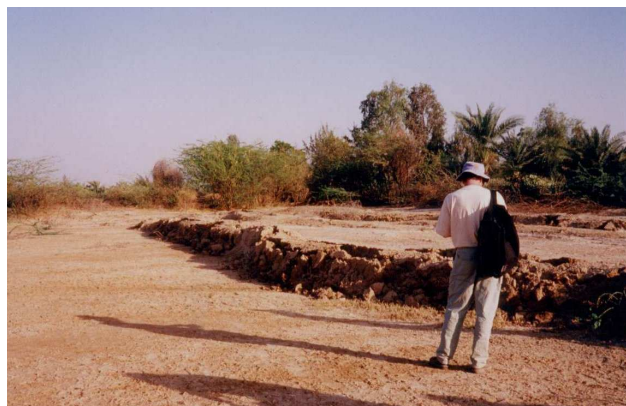
Photo 3.6 : Venue d'eau et de sable.
Dépôts salins blanchâtres. Alignement sur des fractures

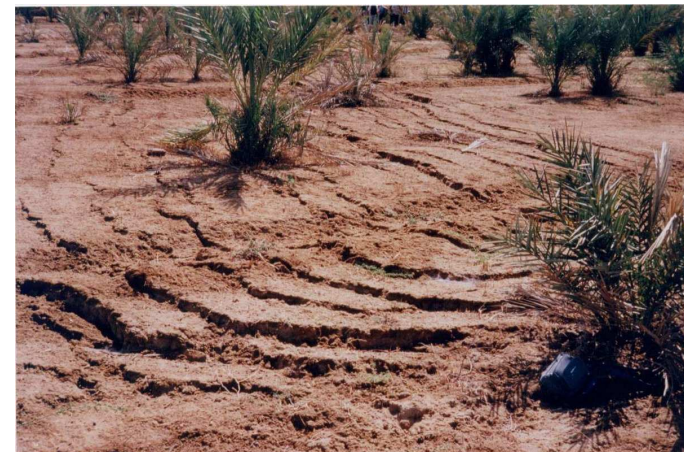
Photo 3.7 : Bourrelet à l'aval d'un glissement horizontal

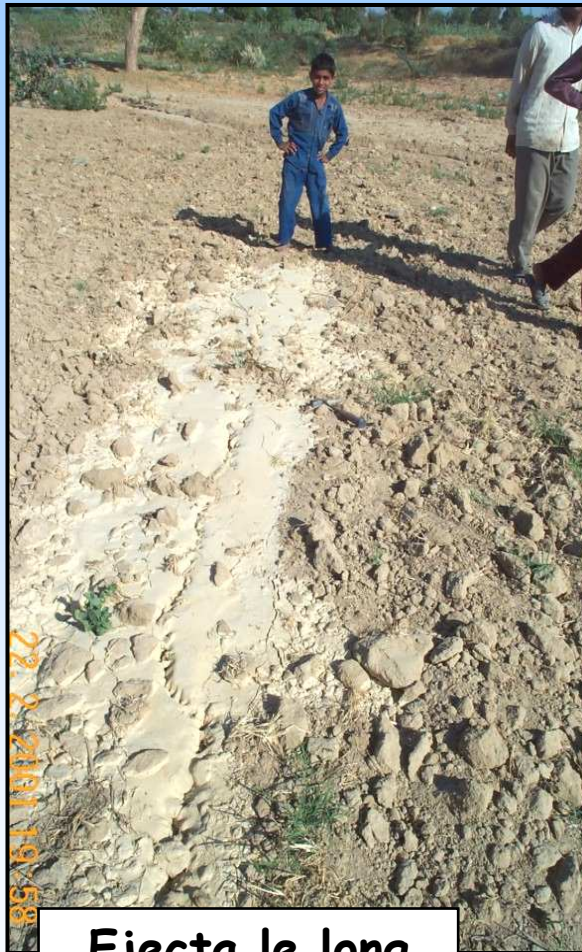
Ejecta le long de fines fissures

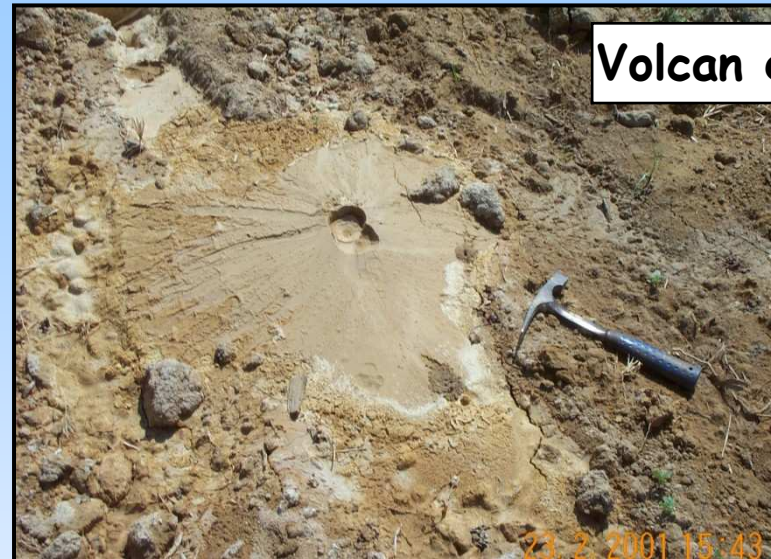
Volcan de sable

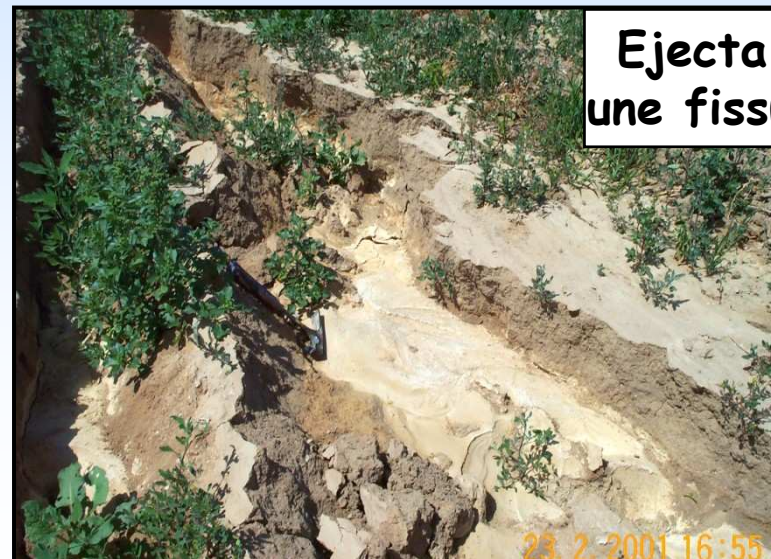
Ejecta comblant une fissure large

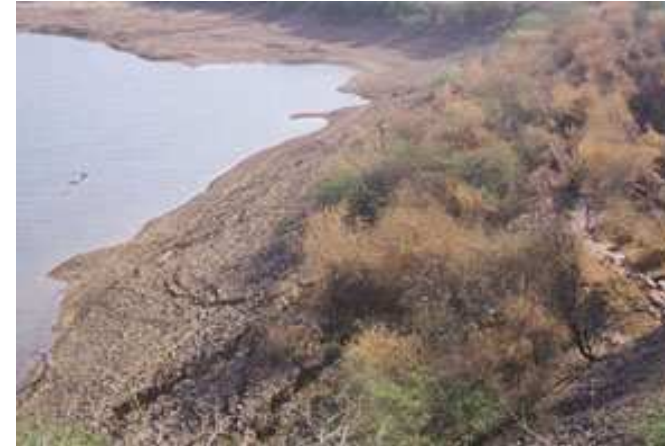
Photo 3.11 : Rupture majeure du corps du barrage. Détail des ruptures côté amont : Avancée du talus et bourrelets émergeant dans le lac.

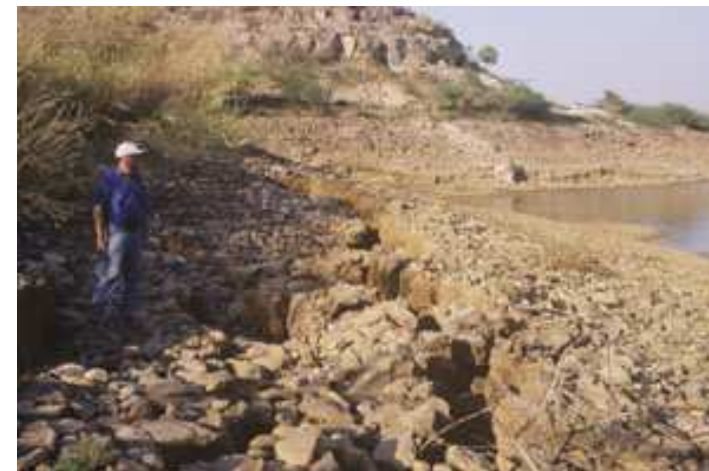
Photo 3.14 : Rupture du talus amont.
En arrière plan, chute de bloc et rupture de berge par liquéfaction.

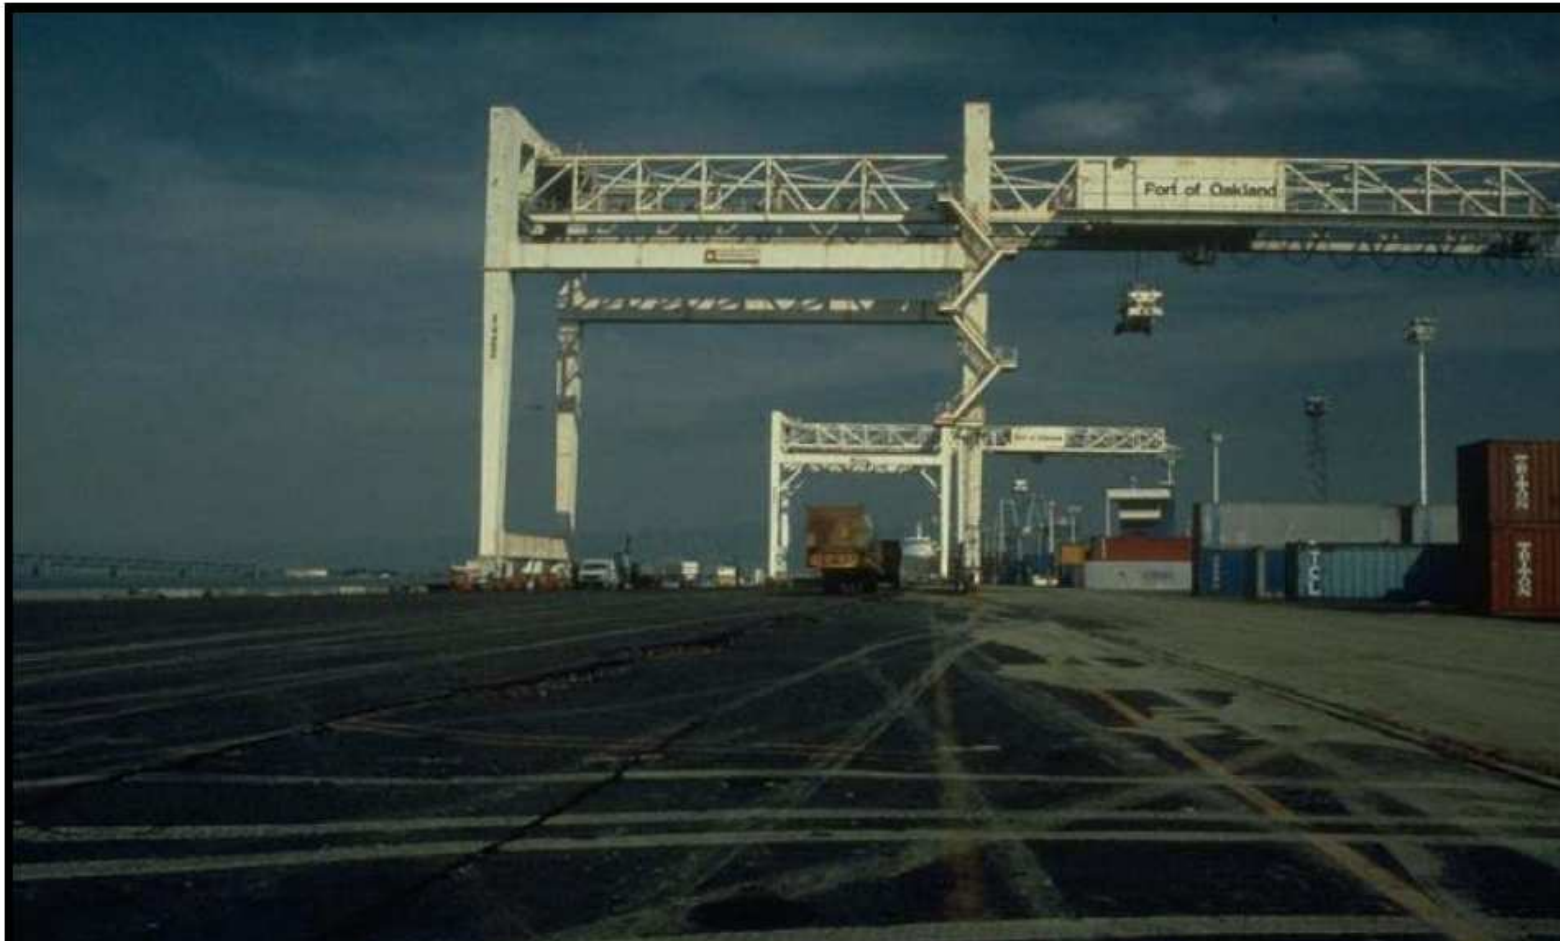
1989 Loma Prieta Earthquake – Port of Oakland
7th Street Marine Terminal
Source – R. Kayen, U.S. Geological Survey and Loma Prieta Collection,
Earthquake Engineering Research Center, University of California, Berkeley

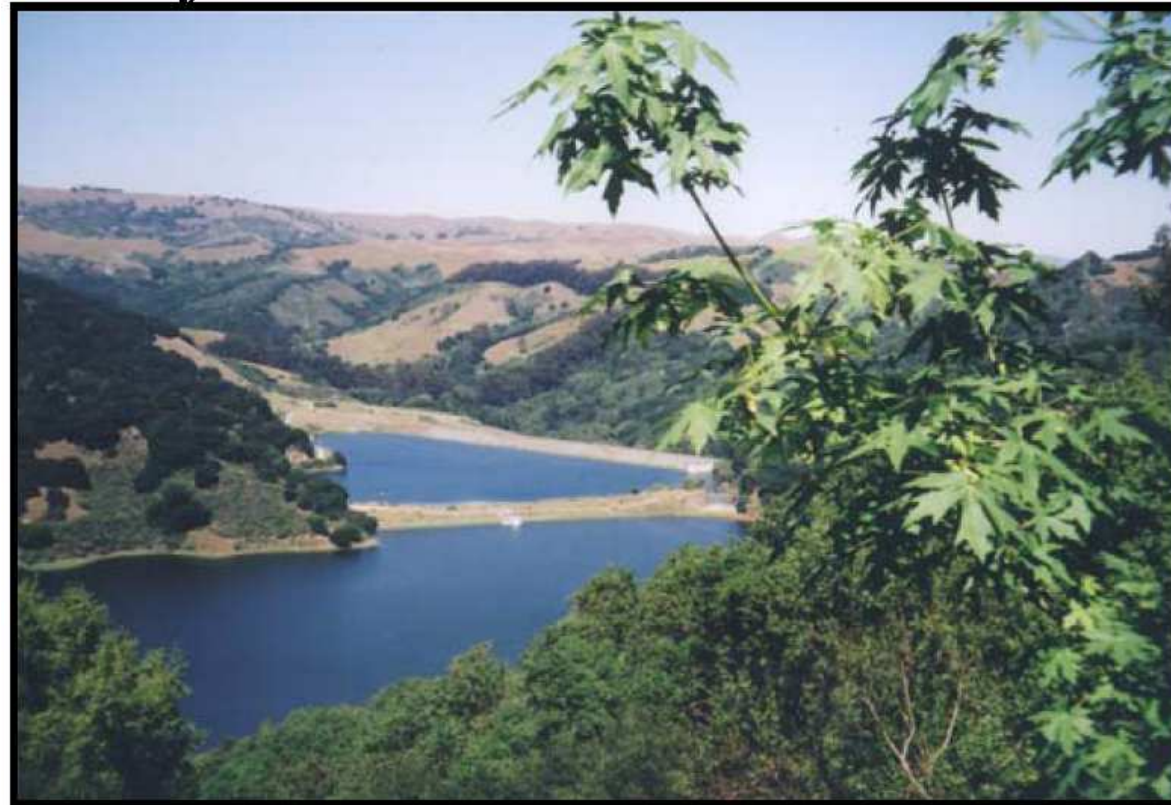
Upper San Leandro Reservoir
showing original hydraulic fill dam
and newer replacement dam
Source – J. Perkins, ABAG
